Remedial Action for Arroyo Hondo State Lead Site

Santa Fe, New Mexico

New Mexico Environment
Department

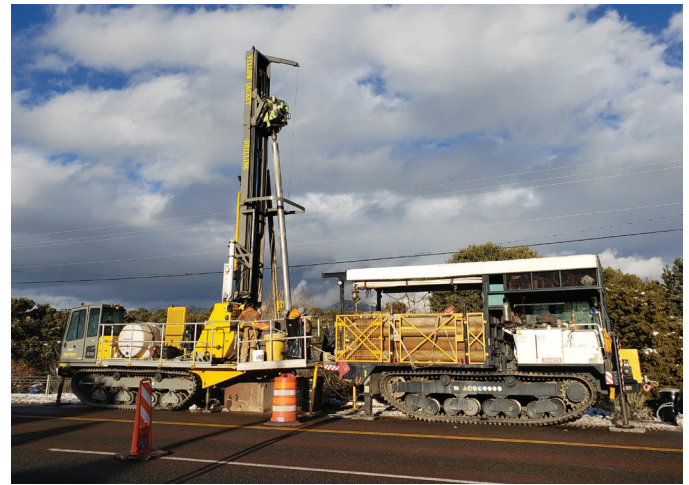
DBS&A provided oversight and CQA for the installation of 20 wells, most of which were installed in highway ROW.

DBS&A recognized early on that additional wells would be needed to address significant gaps in the existing monitor and remediation well network. Twenty new wells were installed through fractured bedrock in two different mobilizations, using a combination of air rotary and sonic drilling technologies. Drilling locations were complicated by variable site topography, dense vegetation, and extensive highway right-of-way (ROW). DBS&A provided geologic oversight and construction quality assurance (CQA) during installation of the wells, as well as regular soil and groundwater sampling.

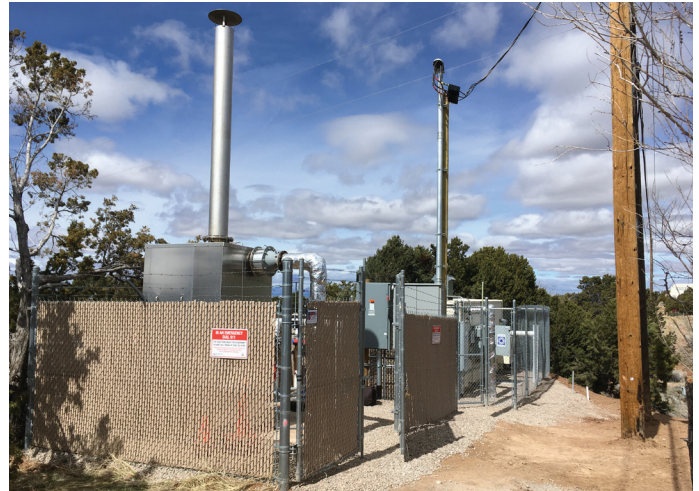
DBS&A creatively engineered larger SVE equipment to fit within a space that is shared by highway ROW and a utility corridor.

After the PSTB approved the FRP, DBS&A led the effort to implement corrective action by providing construction observation, CQA, and developing as-built documentation, including record engineering drawings. DBS&A determined that the existing SVE treatment equipment had exhausted its useful life, so containerized equipment owned by NMED, including an electric catalytic oxidizer, was repurposed from another PSTB site to increase overall system capacity and minimize the overall cost to the client. The SVE blower was provided with a variable frequency drive (VFD) to provide operational flexibility as new remediation wells were connected during SVE system expansion. A state-of-the-art telemetry system provided remote-start capability and alarm notifications that minimized system downtime.
