New Mexico Environment Department, Remedial Services

**New Mexico
Environment
Department**

Jet Grout Barrier and Soil Vapor Extraction Remediation, Santa Fe, New Mexico

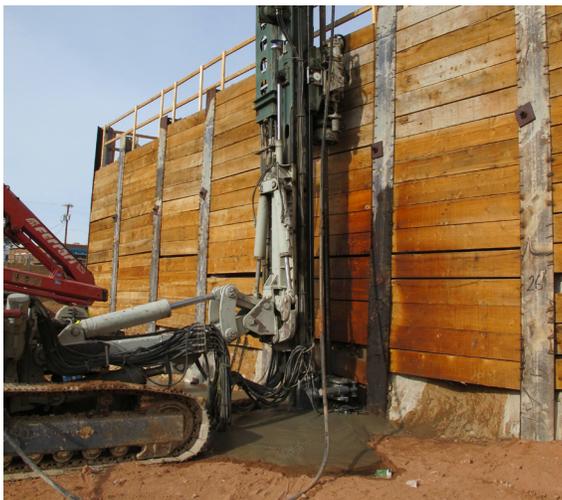
Horizontal wells were installed underneath existing buildings to access the NAPL.

The grout barrier layout consisted of 600 linear feet of jet grouted elements tied to a 185-foot by 22-foot high slurry wall. The only feasible method to access the majority of the NAPL was to install horizontal wells underneath existing buildings. DBS&A designed and oversaw the completion of three horizontal wells; two for soil vapor extraction and one for hot air injection, with a total length of approximately 900 feet. This project is the first application of horizontal SVE wells by the NMED.

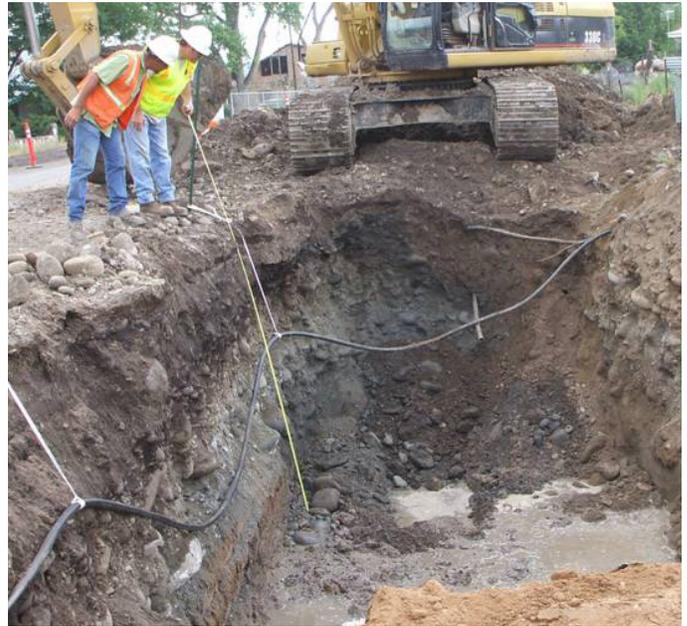
The remediation process required soils beneath NM 75 to be excavated, while keeping the highway open to traffic.

DBS&A completed remedial actions that included the excavation and off-site disposal of more than 10,000 cubic yards of petroleum-contaminated soil and replacement of the community water distribution line. The project was complicated by the need to excavate soils beneath NM 75, while keeping the highway open. Throughout the project, DBS&A coordinated with several groups including the NMED PSTB and Drinking Water Bureau, the New Mexico Department of Transportation, and Picuris Pueblo. The project was completed on-time and on-budget. DBS&A received the New Mexico Chapter of the American Council of Engineering Companies (ACEC) Engineering Excellence Award for the project.
